AFFDL-TR-78-95

LIGHTNING STRIKE SUSCEPTIBILITY TESTS ON THE AIM-9 MISSILE

AUGUST 1978

TECHNICAL REPORT AFFDL-TR-78-95
Final Report for Period October 1977 – November 1977

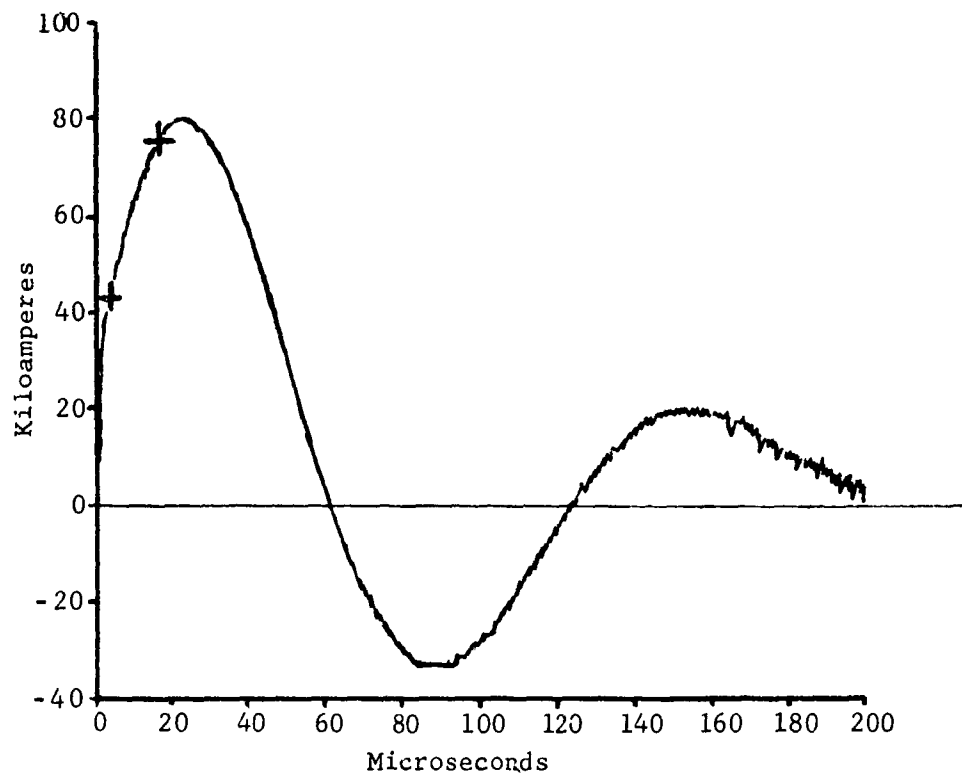
Figure 8. Applied Current Wave to
AIM-9 Missile S/N AJ1355M

Both missiles were subjected to high impulse currents to observe the amount of damage created by the high current arc to the nose of the missile. A peak current of approximately 80 kiloamperes (approximately 93 percentile per Reference 6, Figure 24) was applied to the AIM-9 missile (S/N AJ 1355M) with an arc length of 8 inches. This current value was selected based on an engineering judgment that the missile would be susceptible to damage at this level. The test setup used is shown in Figure 7. With this long arc the mechanical blast effect of a high current impulse due to electrode confinement across a small gap was reduced and the cause of the damage was limited to high current effects. Figure 8 is the applied current waveshape. The complete front of the wave is not shown due to late triggering of the transient digitizer system. The rise-time of the applied current wave was graphically calculated to be 25 microseconds.

On missile S/N AJ 1355M the optical dome was shattered and extreme discoloration and burn marks were observed on the zinc-coated fiberglass housing and around the screw heads at the fiberglass/metal interface.

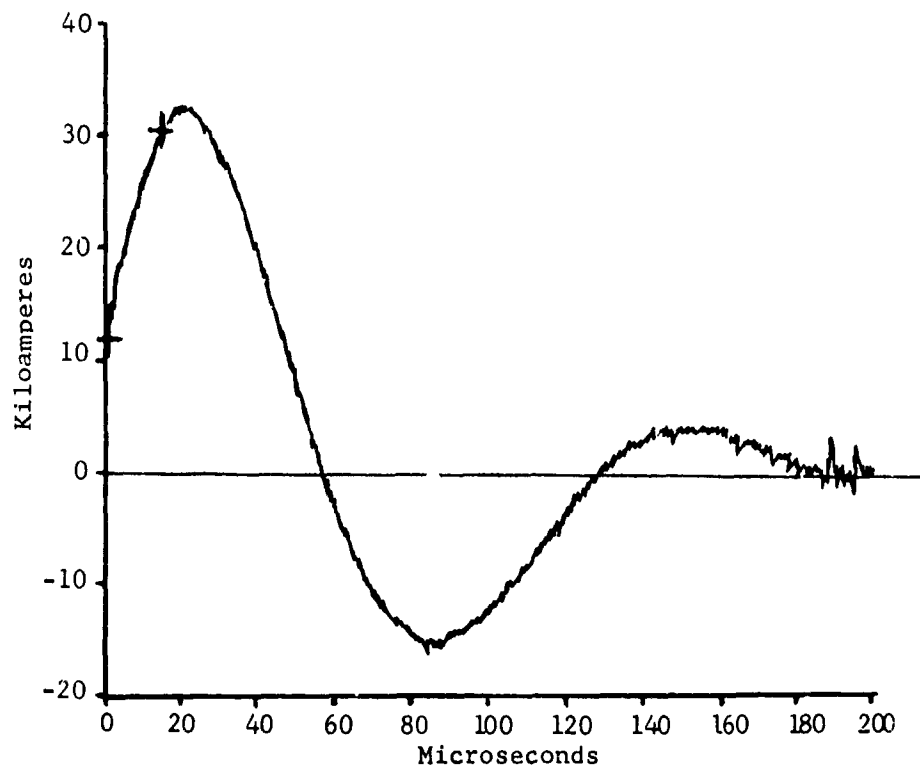
Figure 9. Applied Current Wave to
AIM-9 Missile S/N RLP23372

With the thought of reducing the amount of damage to the second missile, S/N RLP 23372, the peak applied current was reduced to approximately 33 kiloamperes (approximately 72 percentile per Reference 5, Figure 24). This current level approximates an average lightning return stroke. Figure 9 shows the applied current waveshape. Again, the optical dome was shattered and discoloration and burn marks were observed in the same areas as on the first missile. Figure 10 shows the damage done to the front part of both missiles. The destruction of the dome is clearly evident.

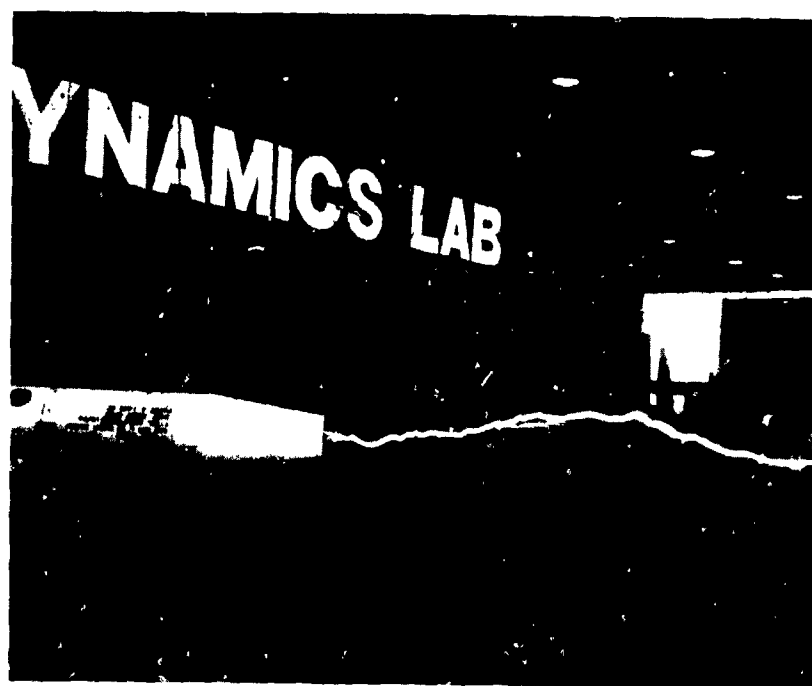
Figure A-11. Arc Attachment to AIM-9 Missile
Test #11, Probe 0° , Horizontal Plane

9	0	Horiz	1.0	Dome/fiberglass housing interface	A-9	Burn mark on underside of missile at fiberglass housing/main-body interface
10	0	Horiz	1.0	Dome/fiberglass housing interface	A-10	No noticeable damage
11	0	Horiz	1.0	Dome/fiberglass housing interface	A-11	No noticeable damage
12	90	Vert	0.95	Dome/fiberglass housing interface	A-12	No noticeable damage
13	75	Vert	0.914	Dome/fiberglass housing interface	A-13	Burn mark at attachment point and top screw of fiberglass housing/main-body interface
14	60	Vert	0.914	Dome/fiberglass housing interface		Burn mark at attachment point
15	45	Vert	0.80	Dome/fiberglass housing interface	A-15	Burn mark at attachment point, burn marks on bottom screw of fiberglass housing/mainbody interface
16	30	Vert	0.80	Dome/fiberglass housing interface	A-16	Burn mark at attachment point and screws of fiberglass housing/main-body interface
17	15	Vert	0.80	Dome/fiberglass housing interface	A-17	Burn damage at attachment point and screws on back side of fiberglass housing/main-body interface
